CASE HISTORIES FROM GREECE

A.I. Sofianos, Member of the Commission, coordinator
K. Karapantelakis, Geologist
N. Koronakis, Mining Engineer
D. Solomos, Mining Engineer

Abstract : Six underground projects encompassing mines, hydroschemes and highway tunnels are investigated as far as rock failure during construction is concerned. Any modes of failure are drawn and the practical measures for overcoming the difficulties are presented.

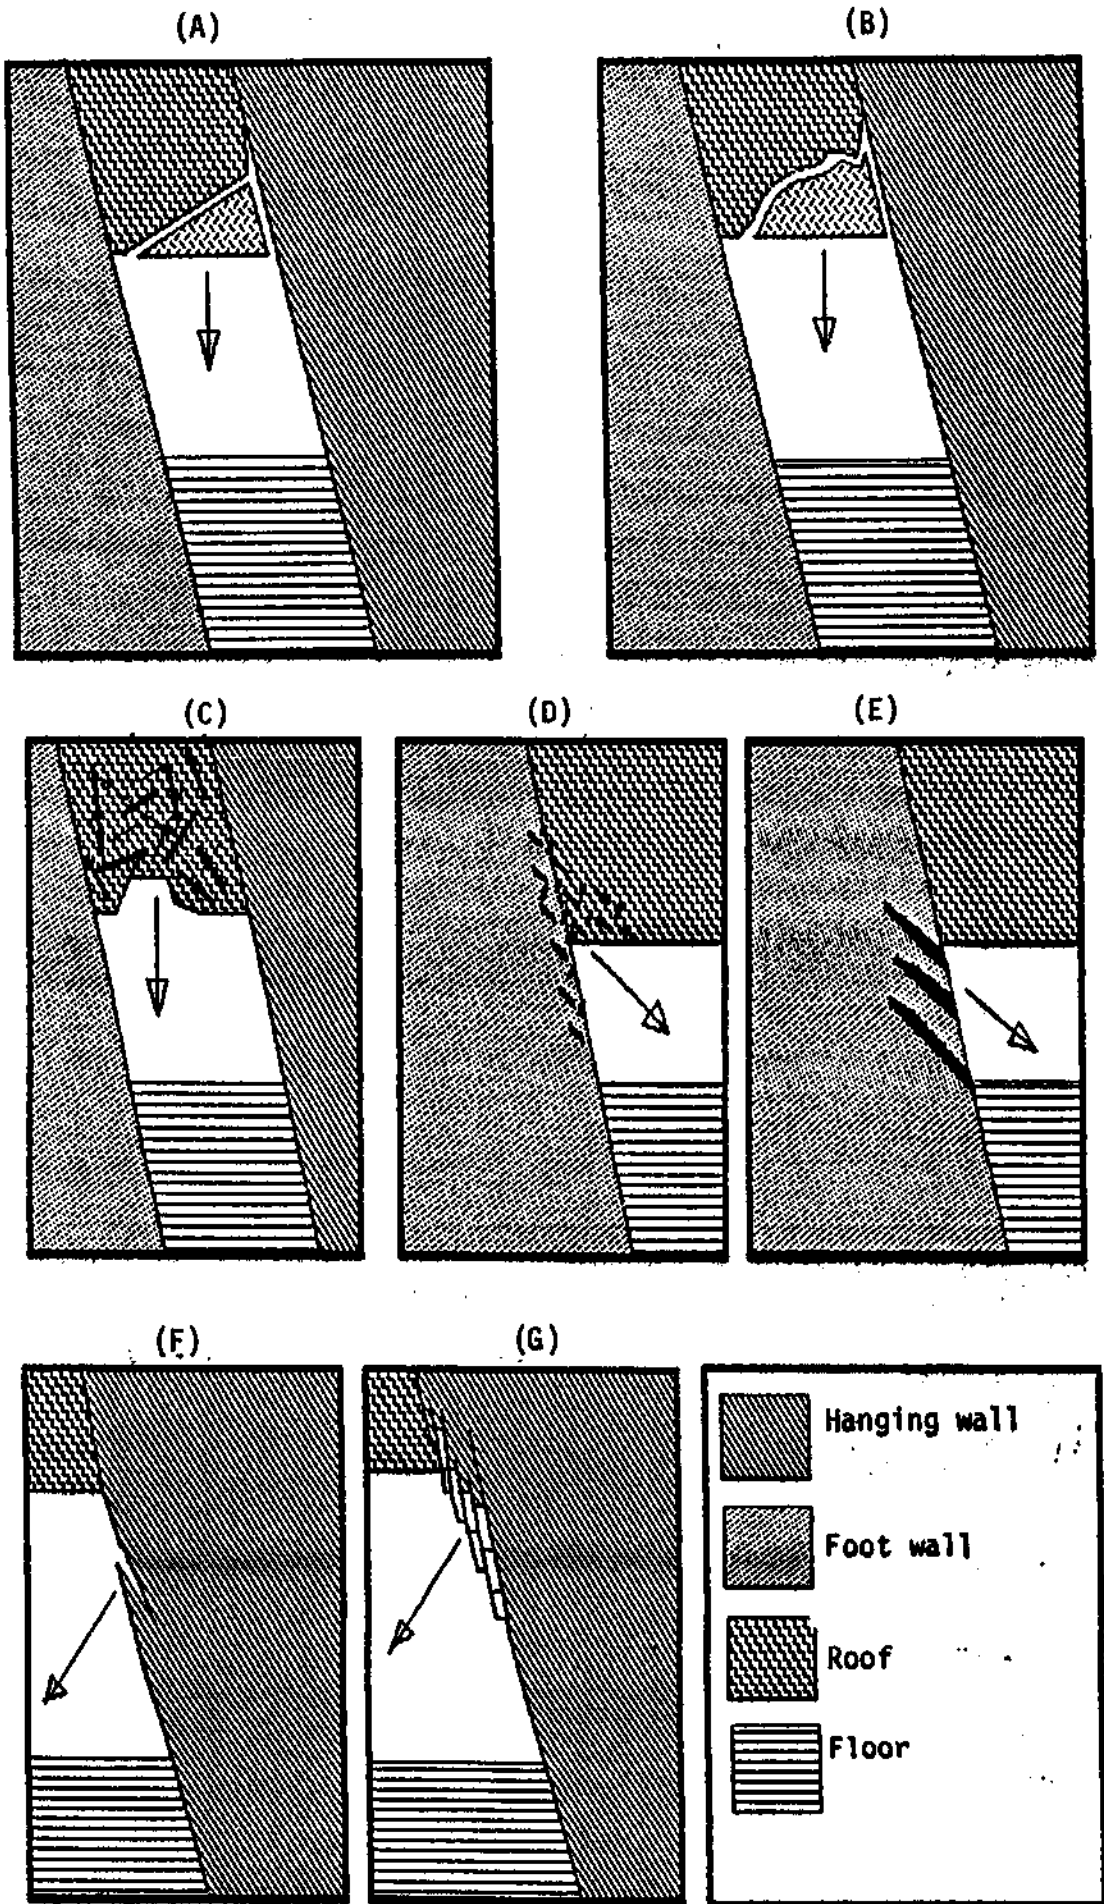
Figure 1. Typical failures at the Skountsa Mine

The rock mass either of the ore or the surrounding rock may be characterized according to CSIR as fair rock with an RMR value 50 to 60 and with an average stand up time between 2 to 4 weeks. High or medium faulting of the rock mass is one of the causes for any instabilities in the underground excavations. Especially difficult in mining are characterized the regions where the dounite is eroded into soft serpentinite. Rock blocks either from the hanging or the footwall fall within the mining faces and cause relative dilution of the mined product. In addition ore blocks fall from the immediate roof, whereas due to the particular prevailing conditions at the shear zones there happen larger scale roof falls.

Most of the problems are due to the structural discontinuities which intersect and form blocks that fail due to their own weight. The rock mass is due to the tectonic stresses highly fractured. The excavation performed with drill and blast method causes high stresses in the surrounding the excavation rock which appear as exfoliations, minor rock block movements and opening of discontinuities. The rate of deformation is extremely high as soon as the hollow room is established, but soon after any deformation stops to appear. The most usual and important rockfall and failure cases are shown in figure 1. Cases (A) and (B) of the figure are present when there is lateral rock pressure. The cause of this type of failure may be attributed to the presence of the chromium grains arranged within bands and which act as rollers. The most abundant type of roof failure is shown as case (C). There are intersecting joints that create irregular rock blocks which equilibrate due to weak stabilizing forces such as friction or solution bonding. These forces are inadequate to bear on

for the stability of the roof. Incipient collapse of large rock blocks derives from the lack of lateral constraint due to the fall of neighbouring smaller blocks. This process is progressive and may result in major rock falls. Failures that occur at the sidewalls of the hanging- or the footwall of the veinshaped deposit appear as in cases (E) or (F) of the figure. Cases (D) or (G) appear seldom, mainly in regions with high lateral pressures, such as where the inclination of the orebody is low and the fill area large, which happens in the last cuts of each sublevel.

Timber and steel is used mainly for the support of the openings, but full contact rockbolts are also employed. Ascending mining causes loosening on the hanging and footwall rock which in turn produces exfoliations and fracturing of the ore in the immediate roof. In general terms we notice an instable physicommechanical behaviour of the rock mass of the mine, which might be apart from the other mentioned causes, due to the high fluctuation of rock stress and especially of the horizontal pressure in the region. There are indications that this results from the sequence of mining. Rockmass might behave viscoplastically due to the high fracturing. When the width of the ore vein is less than this of the mining drift, rock falls are more pronounced due to the presence of new active discontinuities between the ore and the surrounding rock.

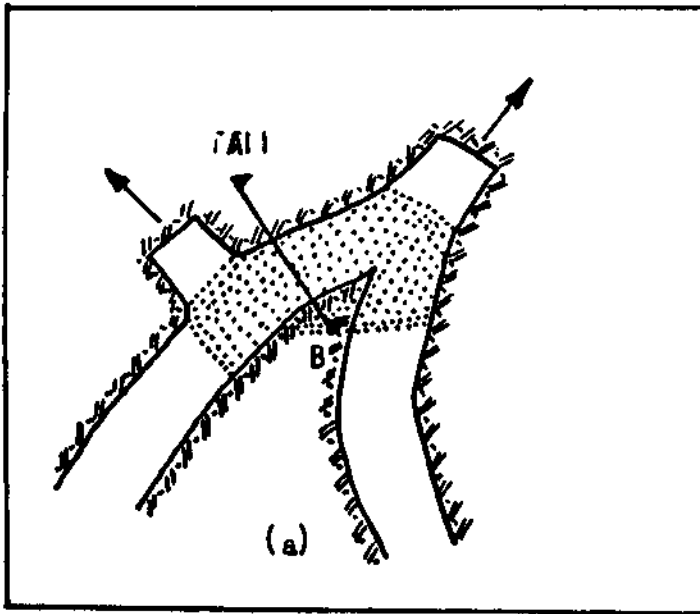
Roof falls may be classified according to their magnitude in two classes. In the first class the boundary or at least its fracture initiation region of any unsafe rock block may extend deeper than the length of the used rockbolts (Fig. 2a). In the second case the rockbolt is long enough to support the rock block. A fall may happen either if there is an insufficient number of bolts which may cause their slip or overstressing, or by tension cracking (Fig. 2b) of the immediate roof between the bolts which causes the fall of usually small fragments.

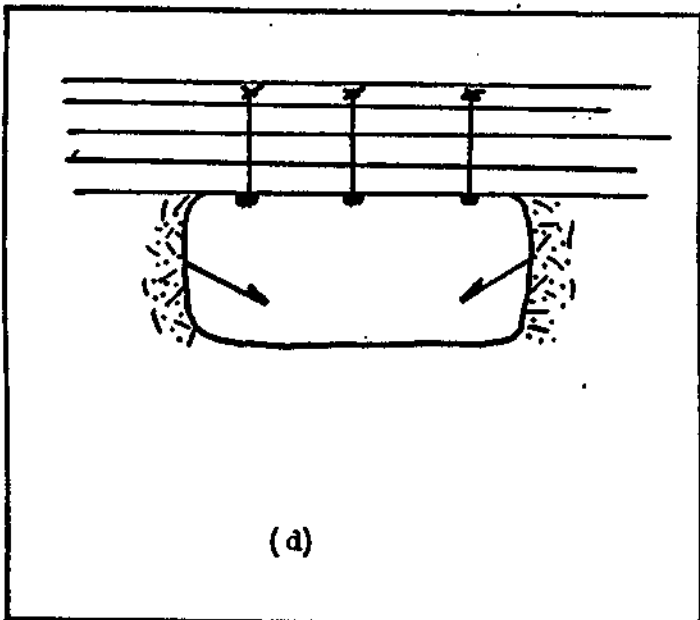
Figure 2. Failures at the Parnassos- Giona underground Bauxite mines

The bolting methods used and their design principles are considered to be productive and successful for a vast range of the rocks surrounding the mining openings of the bauxite ore deposits. Any falls or roof failures are related to very peculiar rock mass conditions, as shown e.g. in figure 2e, in conjunction to unusual arrangements such as cross cuts and junctions.

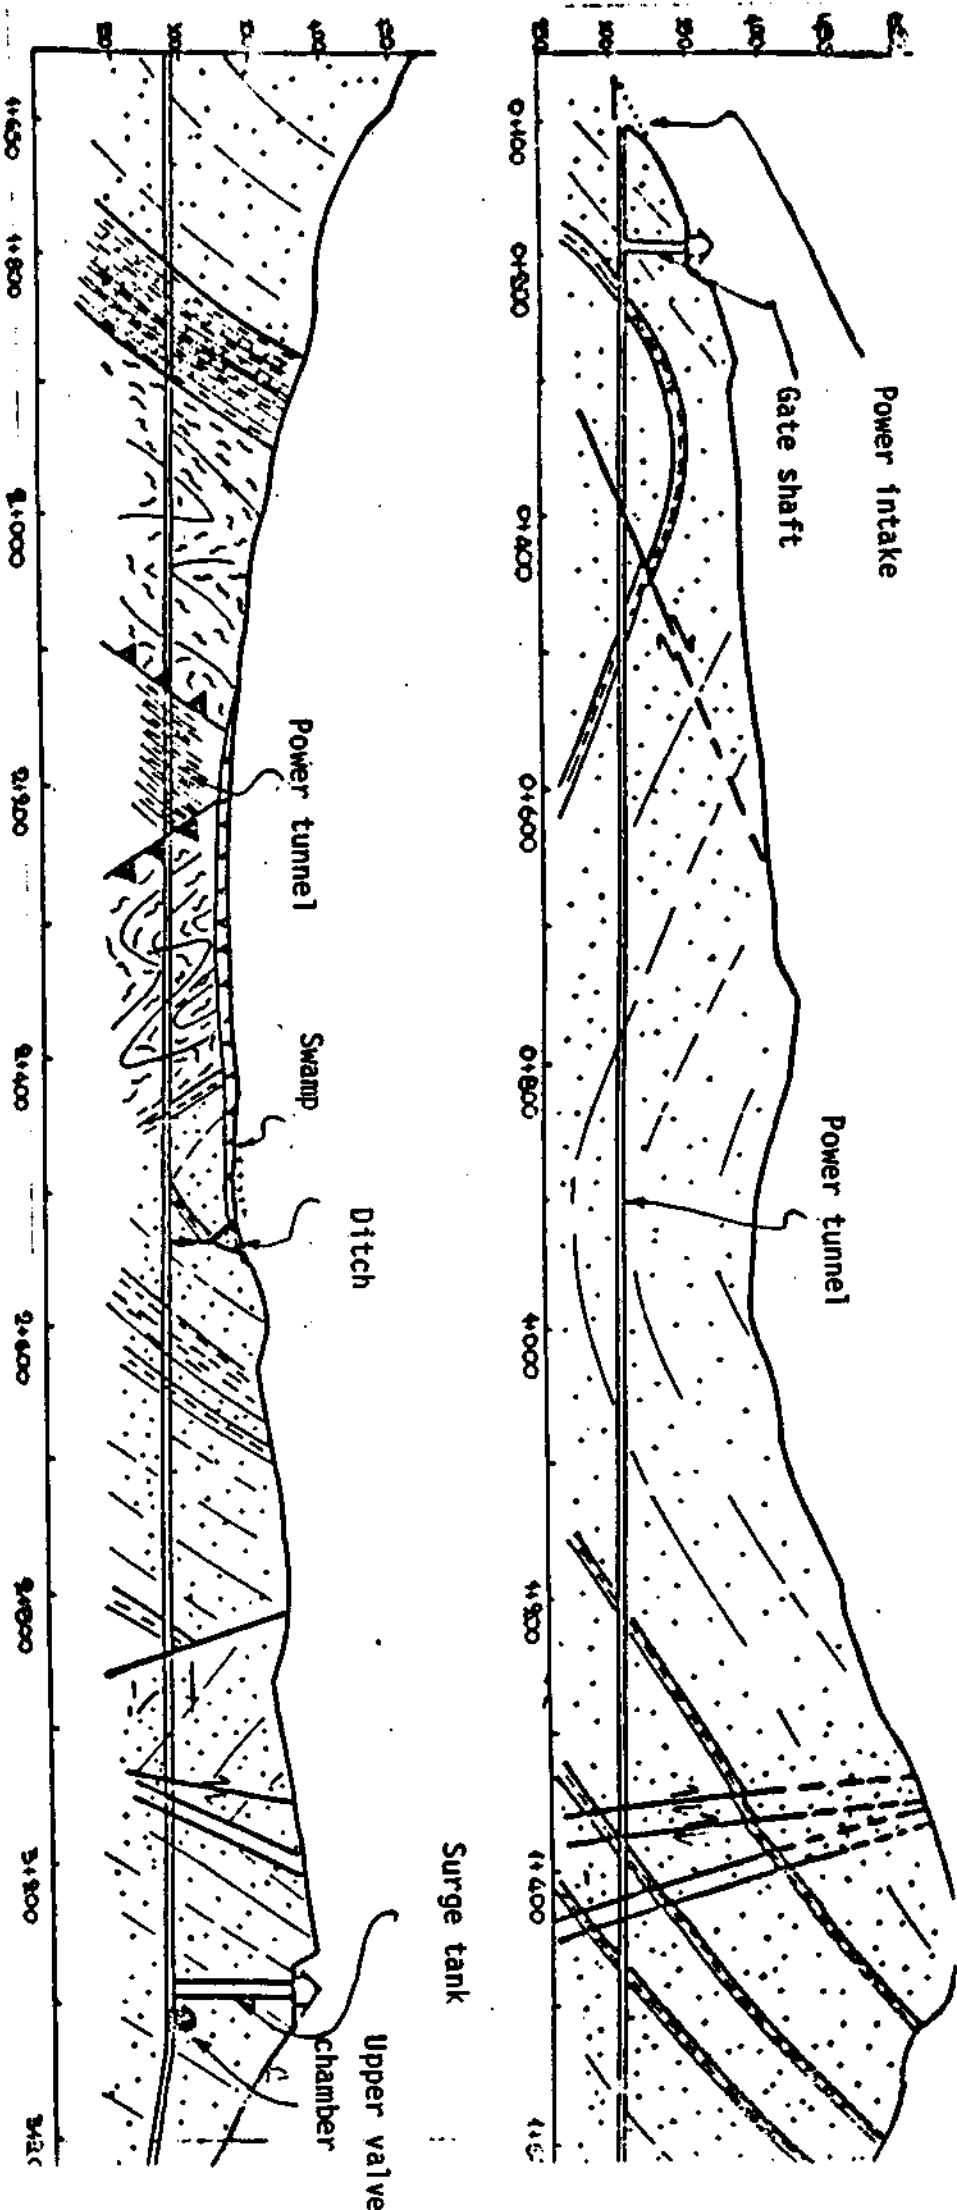
Figure 3. HYDROELECTRIC PROJECT: geological section along waterway

Rock failures mainly structural happened during the excavation in the red siltstone area only, particularly in the region where they appeared heavily fractured. There it

happened a rockfall of approximately 150 cubic meter. The fall was attributed to the high rate of advance of three meter per step. Stability problems were successfully overcome by reducing the rate of advance to one meter and by changing the support measures by incorporating steel ribs.

After the excavation four meter deep cement grouting was injected in order to stabilize the rock which might be disturbed by blasting. The absorption rate of the grout in the sandstone region was as high as four tonnes per meter length.

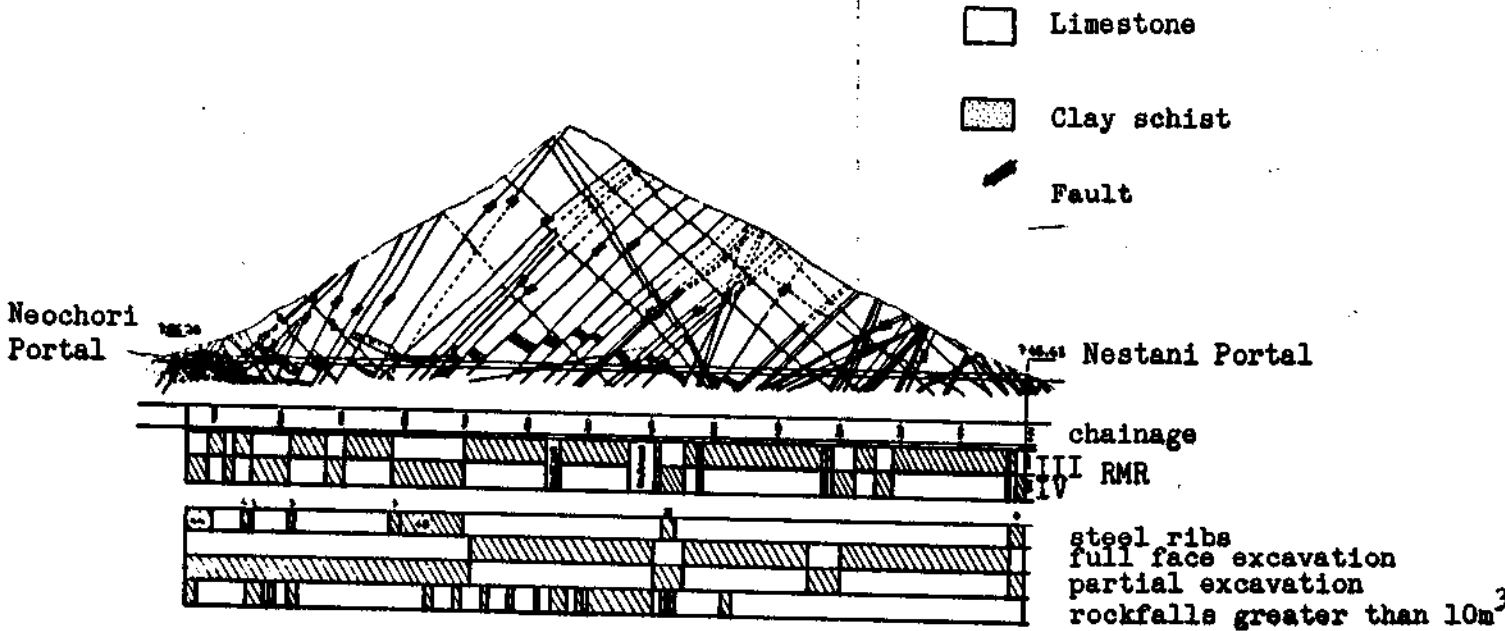
Figure 5. Geology and rockfalls in a longitudinal section of the Artemissio tunnel.

All the rock failures that happened were structural. Those that embodied a rock volume larger than 10 cubic meter are

shown in the figure. There were almost no rockfalls during the first 550 meter in which the rock is characterized as thinly bedded limestone and may be rated according to CSIR as rock mass class III (fair rock). Many rockfalls were anticipated from chainage 550 to 900 although the quality of the rock did not change. This may be attributed to the clay schist layers which appeared unpredictably in the roof or the walls of the excavation and separated limestone blocks. From chainage 900 on as the overthrust line is approached, the schist layers become abundant and the tunnel face may be termed as mixed. A slower rate of advance performed in two stages, the immediate application of support and the installation of steel ribs, prohibited almost any rockfalls until chainage 1175. In the region of the overthrust line from chainage 1175 to 1250 many rockfalls occurred although the excavation proceeded very carefully in more than one stages. In this region convergences as high as 39mm were measured. Within the clay schist area from chainage 1250 on there were almost no rockfalls although the rockmass might be classified according to CSIR as rock mass class IV (poor rock). Apart from the very cautious excavation process, this may be attributed to the period of performing it, which was a dry one that did leave the clay schists dry.
