CASE HISTORIES FROM GREECE

A.I. Sofianos, Member of the Commission, coordinator
K. Karapantelakis, Geologist
N. Koronakis, Mining Engineer
D. Solomos, Mining Engineer

Abstract : Six underground projects encompassing mines, hydroschemes and highway tunnels are investigated as far as rock failure during construction is concerned. Any modes of failure are drawn and the practical measures for overcoming the difficulties are presented.

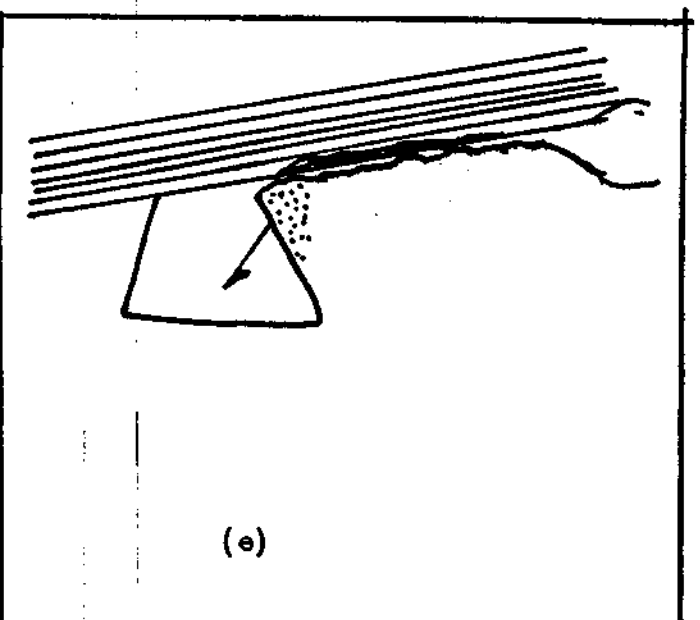
Figure 2. Failures at the Parnassos- Giona underground Bauxite mines

Roof falls may be classified according to their magnitude in two classes. In the first class the boundary or at least its fracture initiation region of any unsafe rock block may extend deeper than the length of the used rockbolts (Fig. 2a). In the second case the rockbolt is long enough to support the rock block. A fall may happen either if there is an insufficient number of bolts which may cause their slip or overstressing, or by tension cracking (Fig. 2b) of the immediate roof between the bolts which causes the fall of usually small fragments.

In some cases failure does not happen along critical discontinuity planes with clay infill, but along fractures created after the formation of the opening due to stress concentration (Fig. 2c). This new planes may combine with the structural discontinuities of the parent rock mass and form unstable rock blocks.

Designers believe that the existing pillar faces are not adequately strong due to their fracturing or injuring during the drill and blast process (Fig. 2d). Hence the stability of the room should be based on a reduced support area of the pillar and a larger span of the room.

The bolting methods used and their design principles are considered to be productive and successful for a vast range of the rocks surrounding the mining openings of the bauxite ore deposits. Any falls or roof failures are related to very peculiar rock mass conditions, as shown e.g. in figure 2e, in conjunction to unusual arrangements such as cross cuts and junctions.

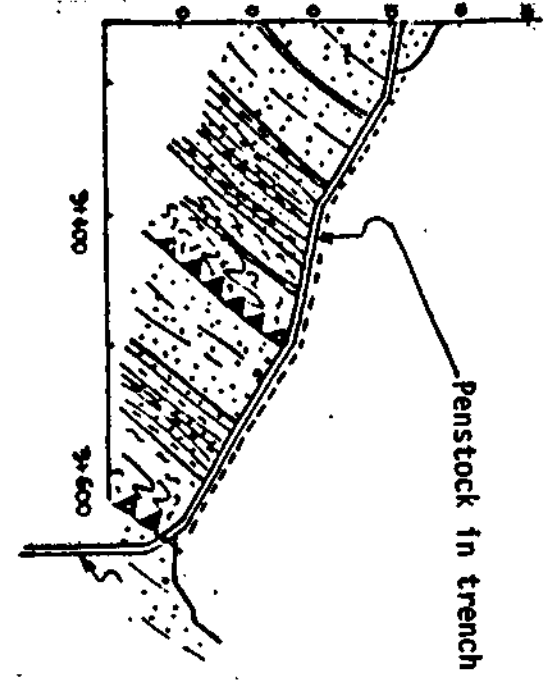
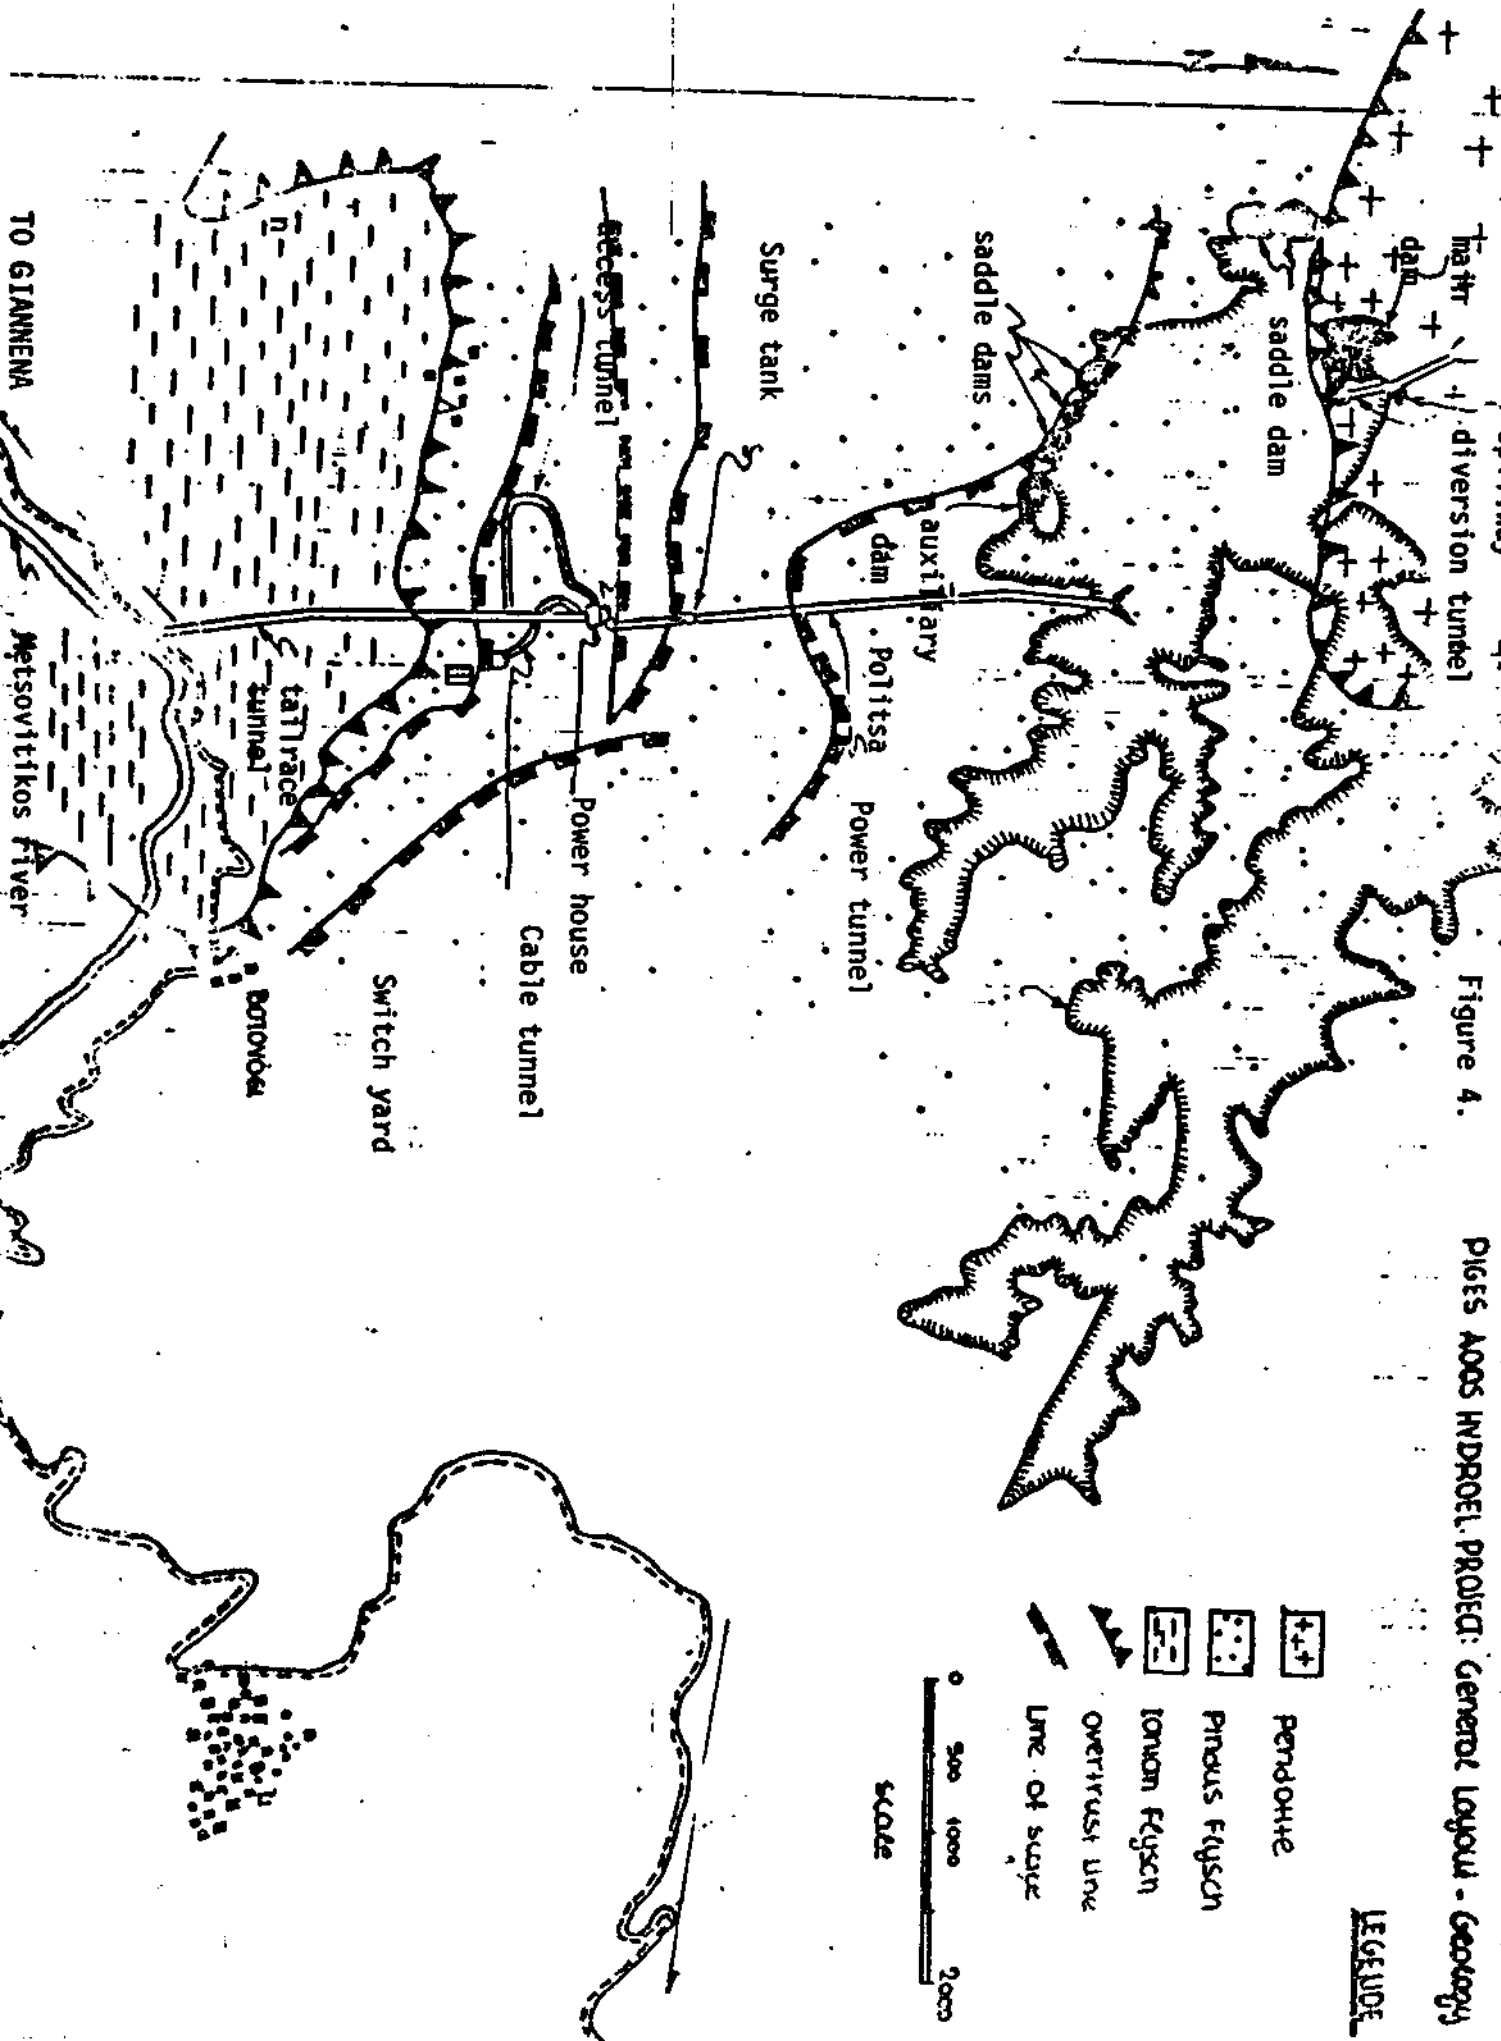
Figure 4. PIGES AODS HYDROEL. PROJECT: General layout - Geology

The diversion tunnel is 650 meter long and its cross section is 19 square meter. It has been excavated entirely within peridotites. Its entrance lies at a distance of 250 meter from the overthrust line (Fig. 4). In the 300 first meter the rock mass was heavily fractured and serpentized which was then reduced. Heavy stability problems were encountered in the former region such as :

Many rockfalls occurred of which four incorporated a volume of 40 to 50 cubic meter each. Those occurred prior to the installation of the support measures. After their installation there were none but one visually observable displacement. The latter concerns a ten meter region of the tunnel at the interface of the highly fractured with the less fractured peridotite in which the water discharge was

Rockfalls happened in a progressive manner. They initiated with small wedge failures from the roof and proceeded into a complete rockfall in about two hours. This was attributed to the high fracturing and the erosion of the rockmass and the slickensided nature of the walls of the discontinuities. High stress concentration was created after the removal of any rock block which accelerated the precipitation. Hence of primary importance is not the kind but the time of installation of the support measures. This ranged from a half to two hours for the particular excavation that advanced with a rate of 0.7 to 1 meter per step at the top heading.
